To: Stonegate on the Lake HOA

Re: Lot Assessment Summary and Recommendations  
 WSB Project No. 031723-000

### Project Background

### History of Bluff Impacts

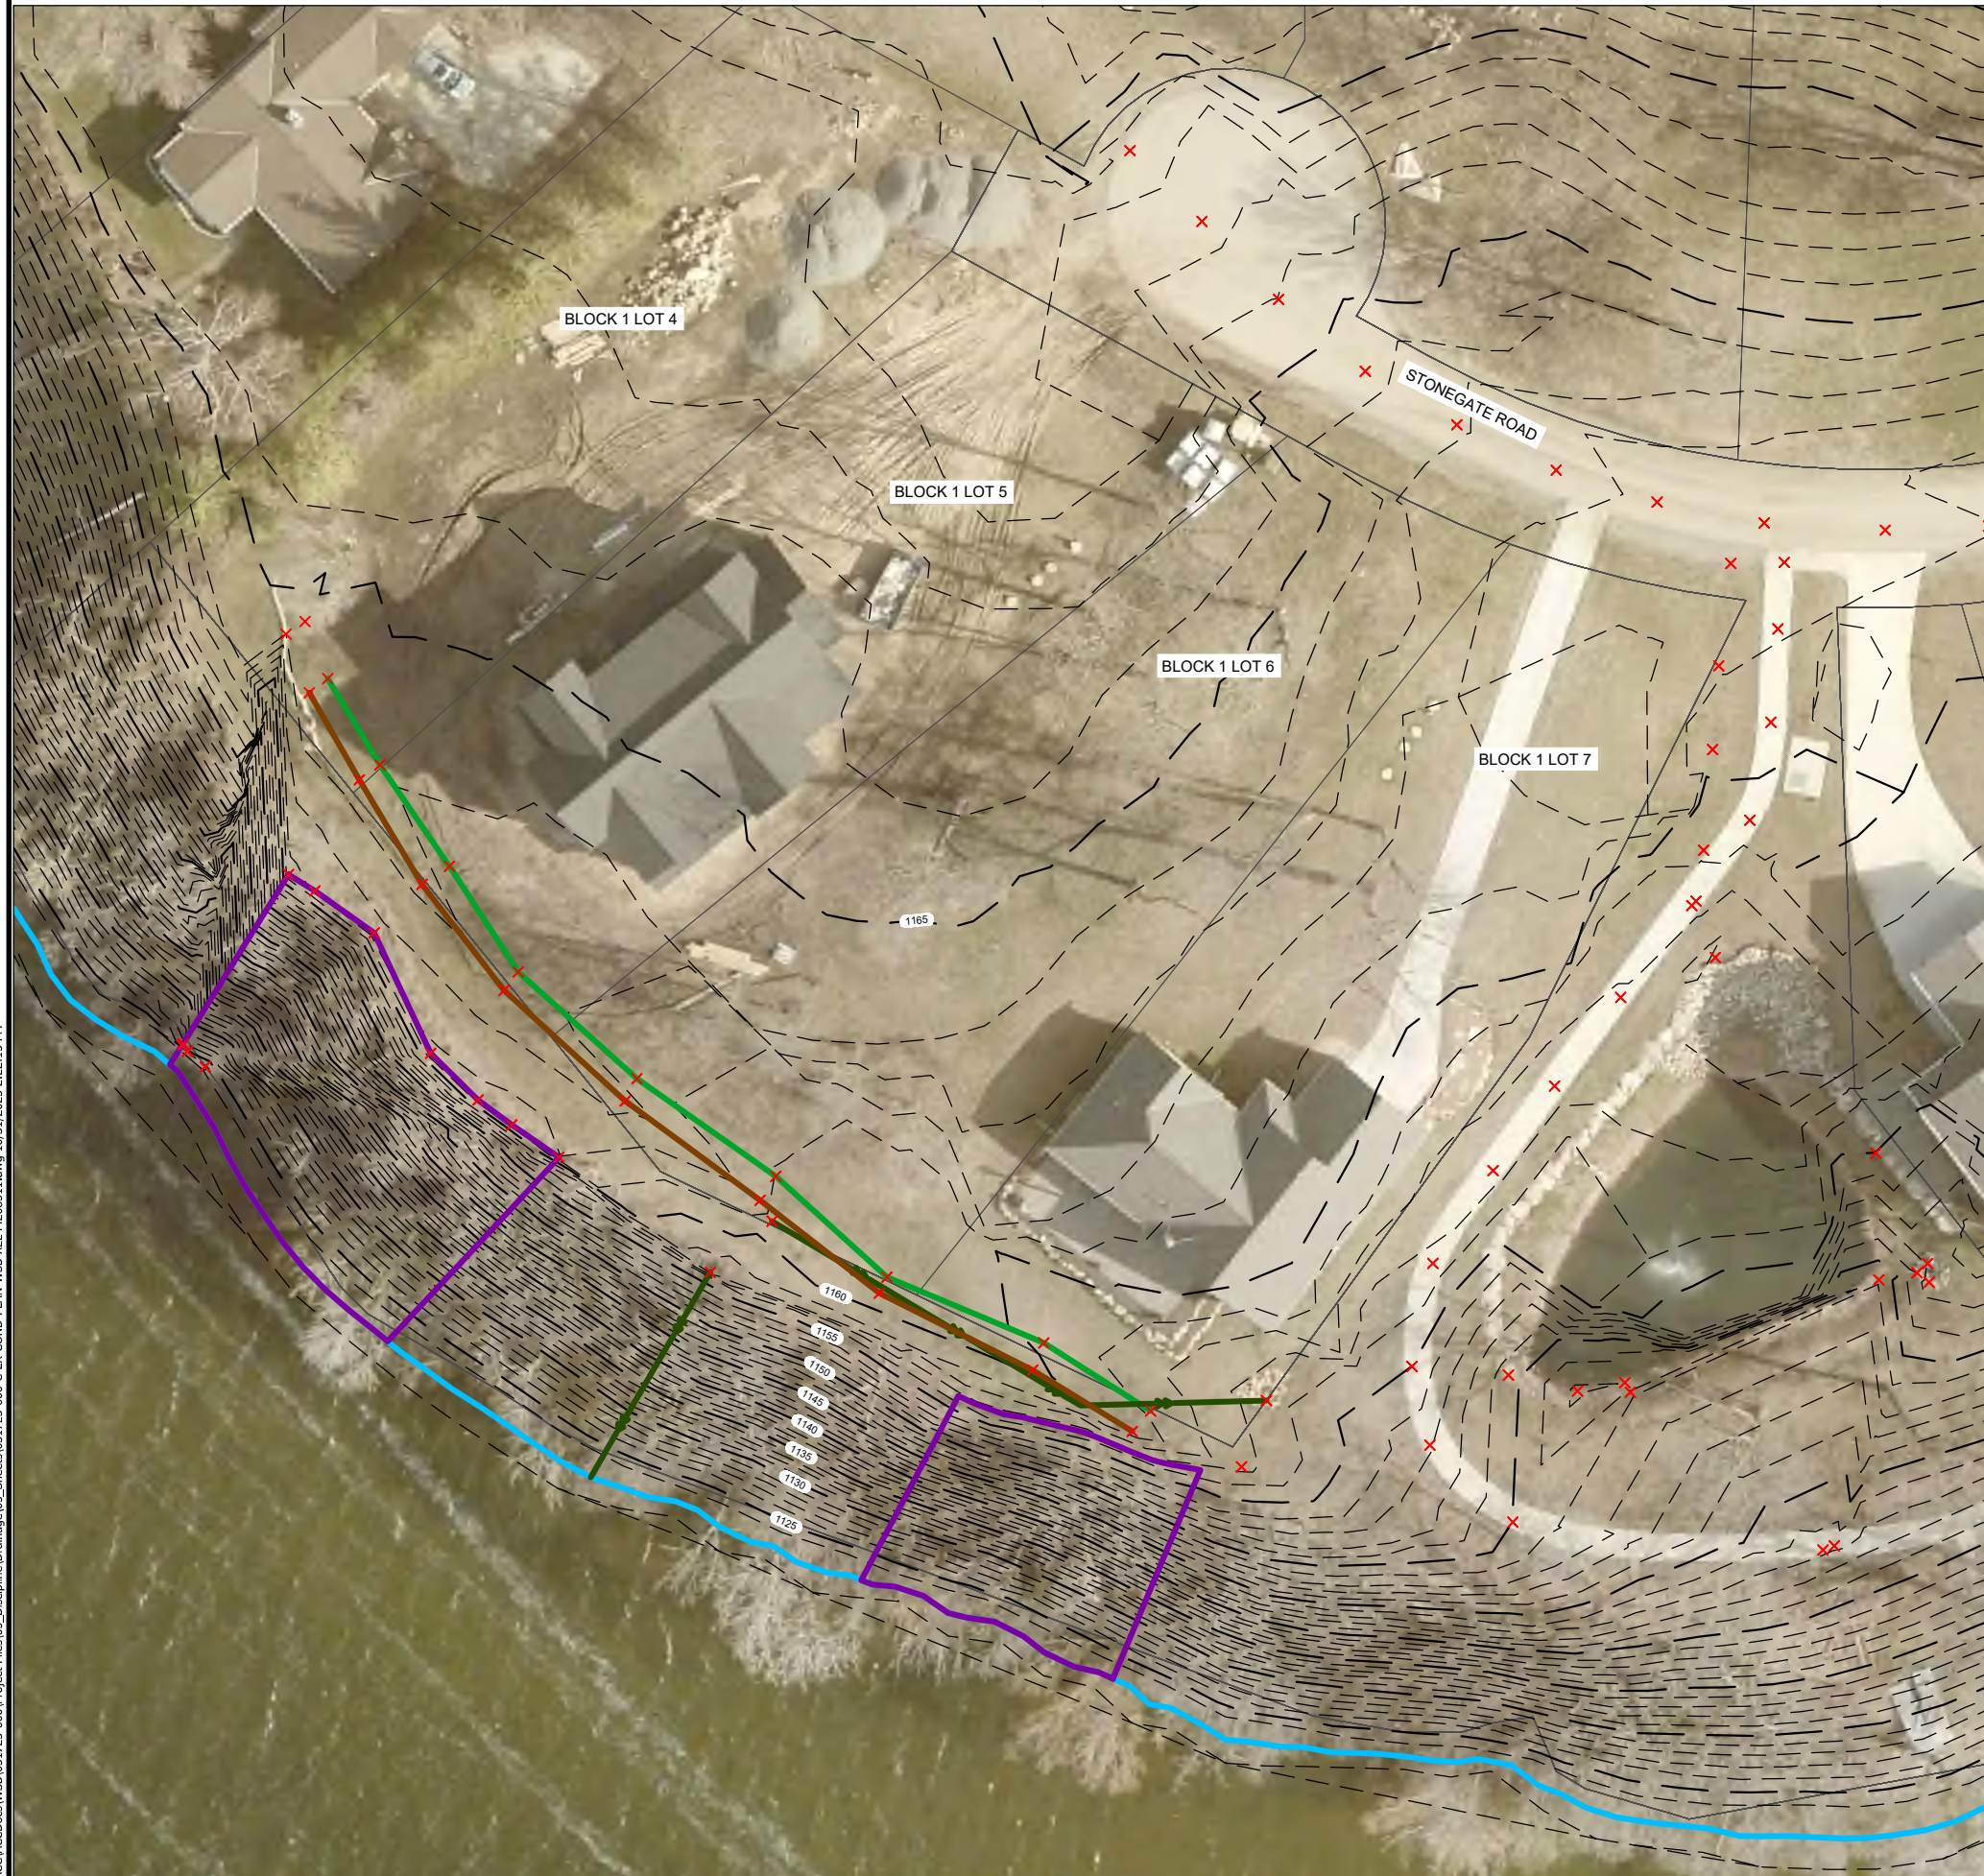
FIGURE 1  
 EXISTING  
 CONDITIONS

WSB completed an on-site evaluation of existing conditions on October 3<sup>rd</sup>, 2025. WSB documented the existing conditions using photos and survey equipment and also discussed drainage issues and concerns with existing residents. Selected photos from the site visit are shown in Appendix B. WSB also surveyed the top and bottom of the existing bluff. The existing conditions are shown in Figure 1. The grading plan for the entire subdivision is shown in Appendix C.

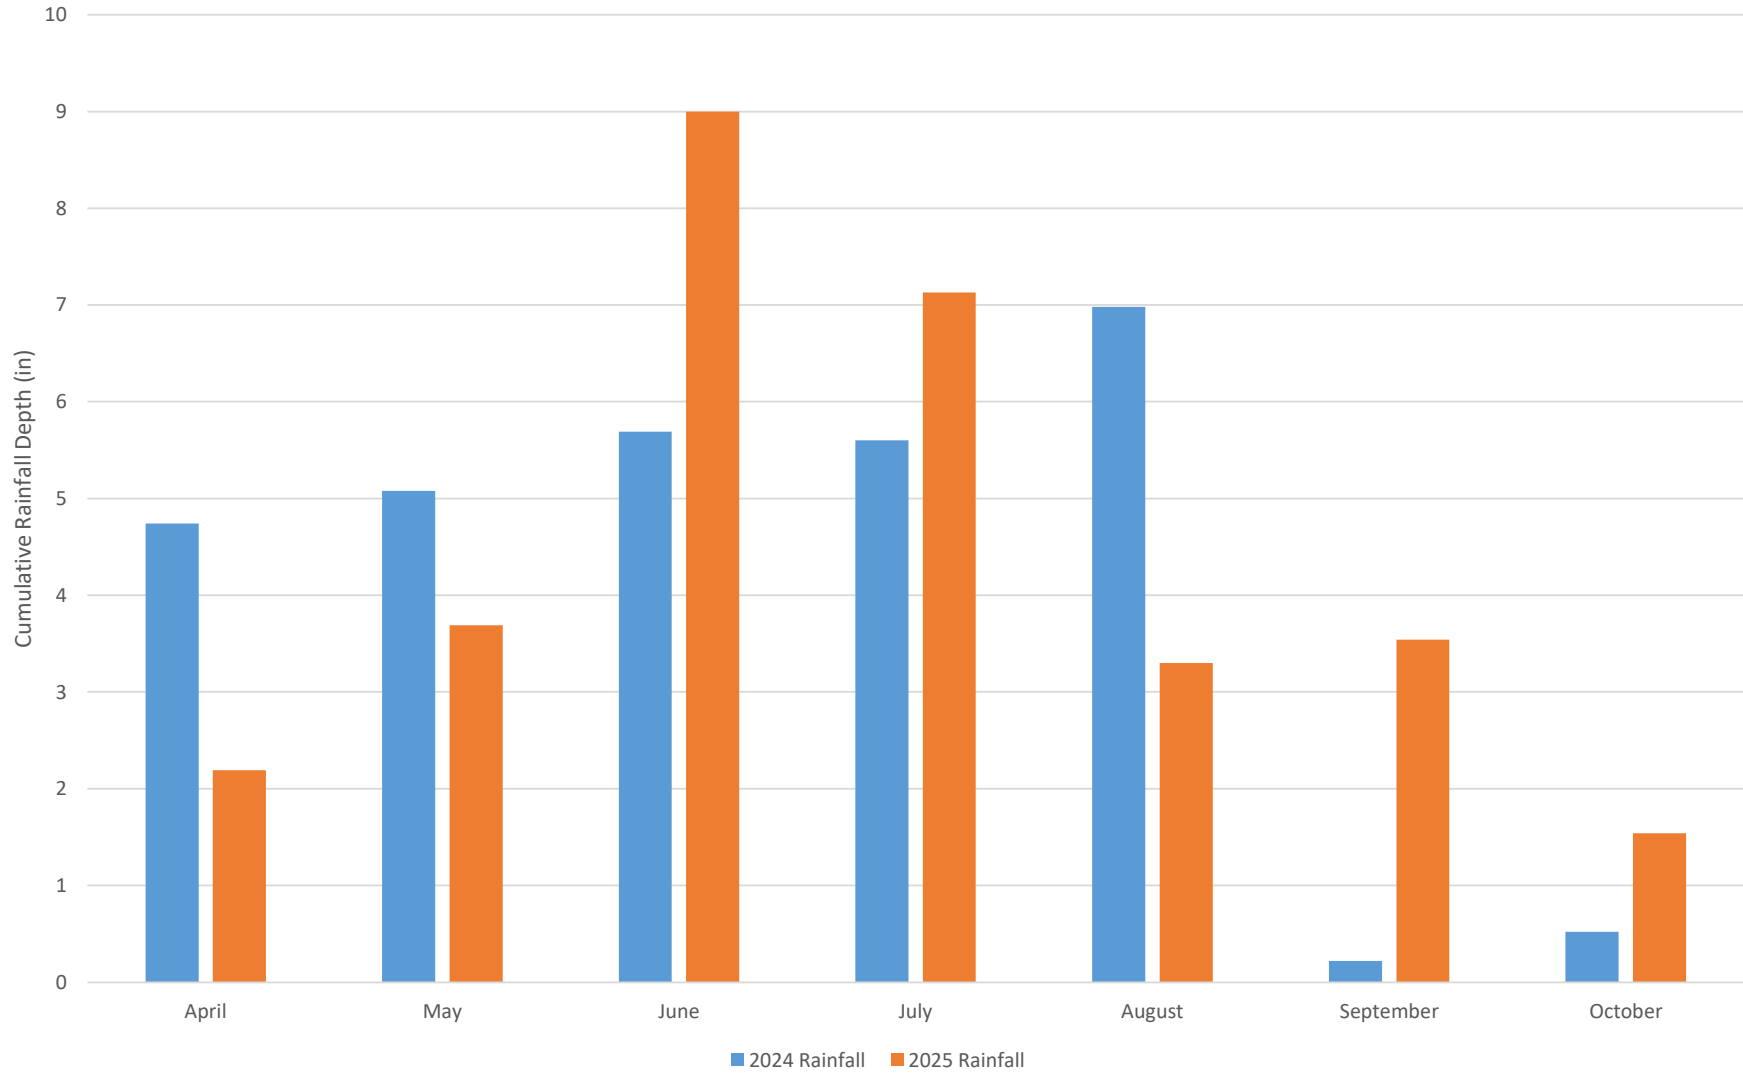
Figure 2 - 2024 and 2025 Total Precipitation by Month CoCoRAS Station #MN-SR-42

Table 1 - Monthly Precipitation Data (Station #MN-SR-42)		
Month	2024 Rainfall (in)	2025 Rainfall (in)
April	4.74	2.19
May	5.08	3.69
June	5.69	9.00

July	5.6	7.13
August	6.98	3.30
September	0.22	3.54
October	0.52	1.54
<b>Total Rainfall (in)</b>	<b>28.83</b>	<b>30.39</b>

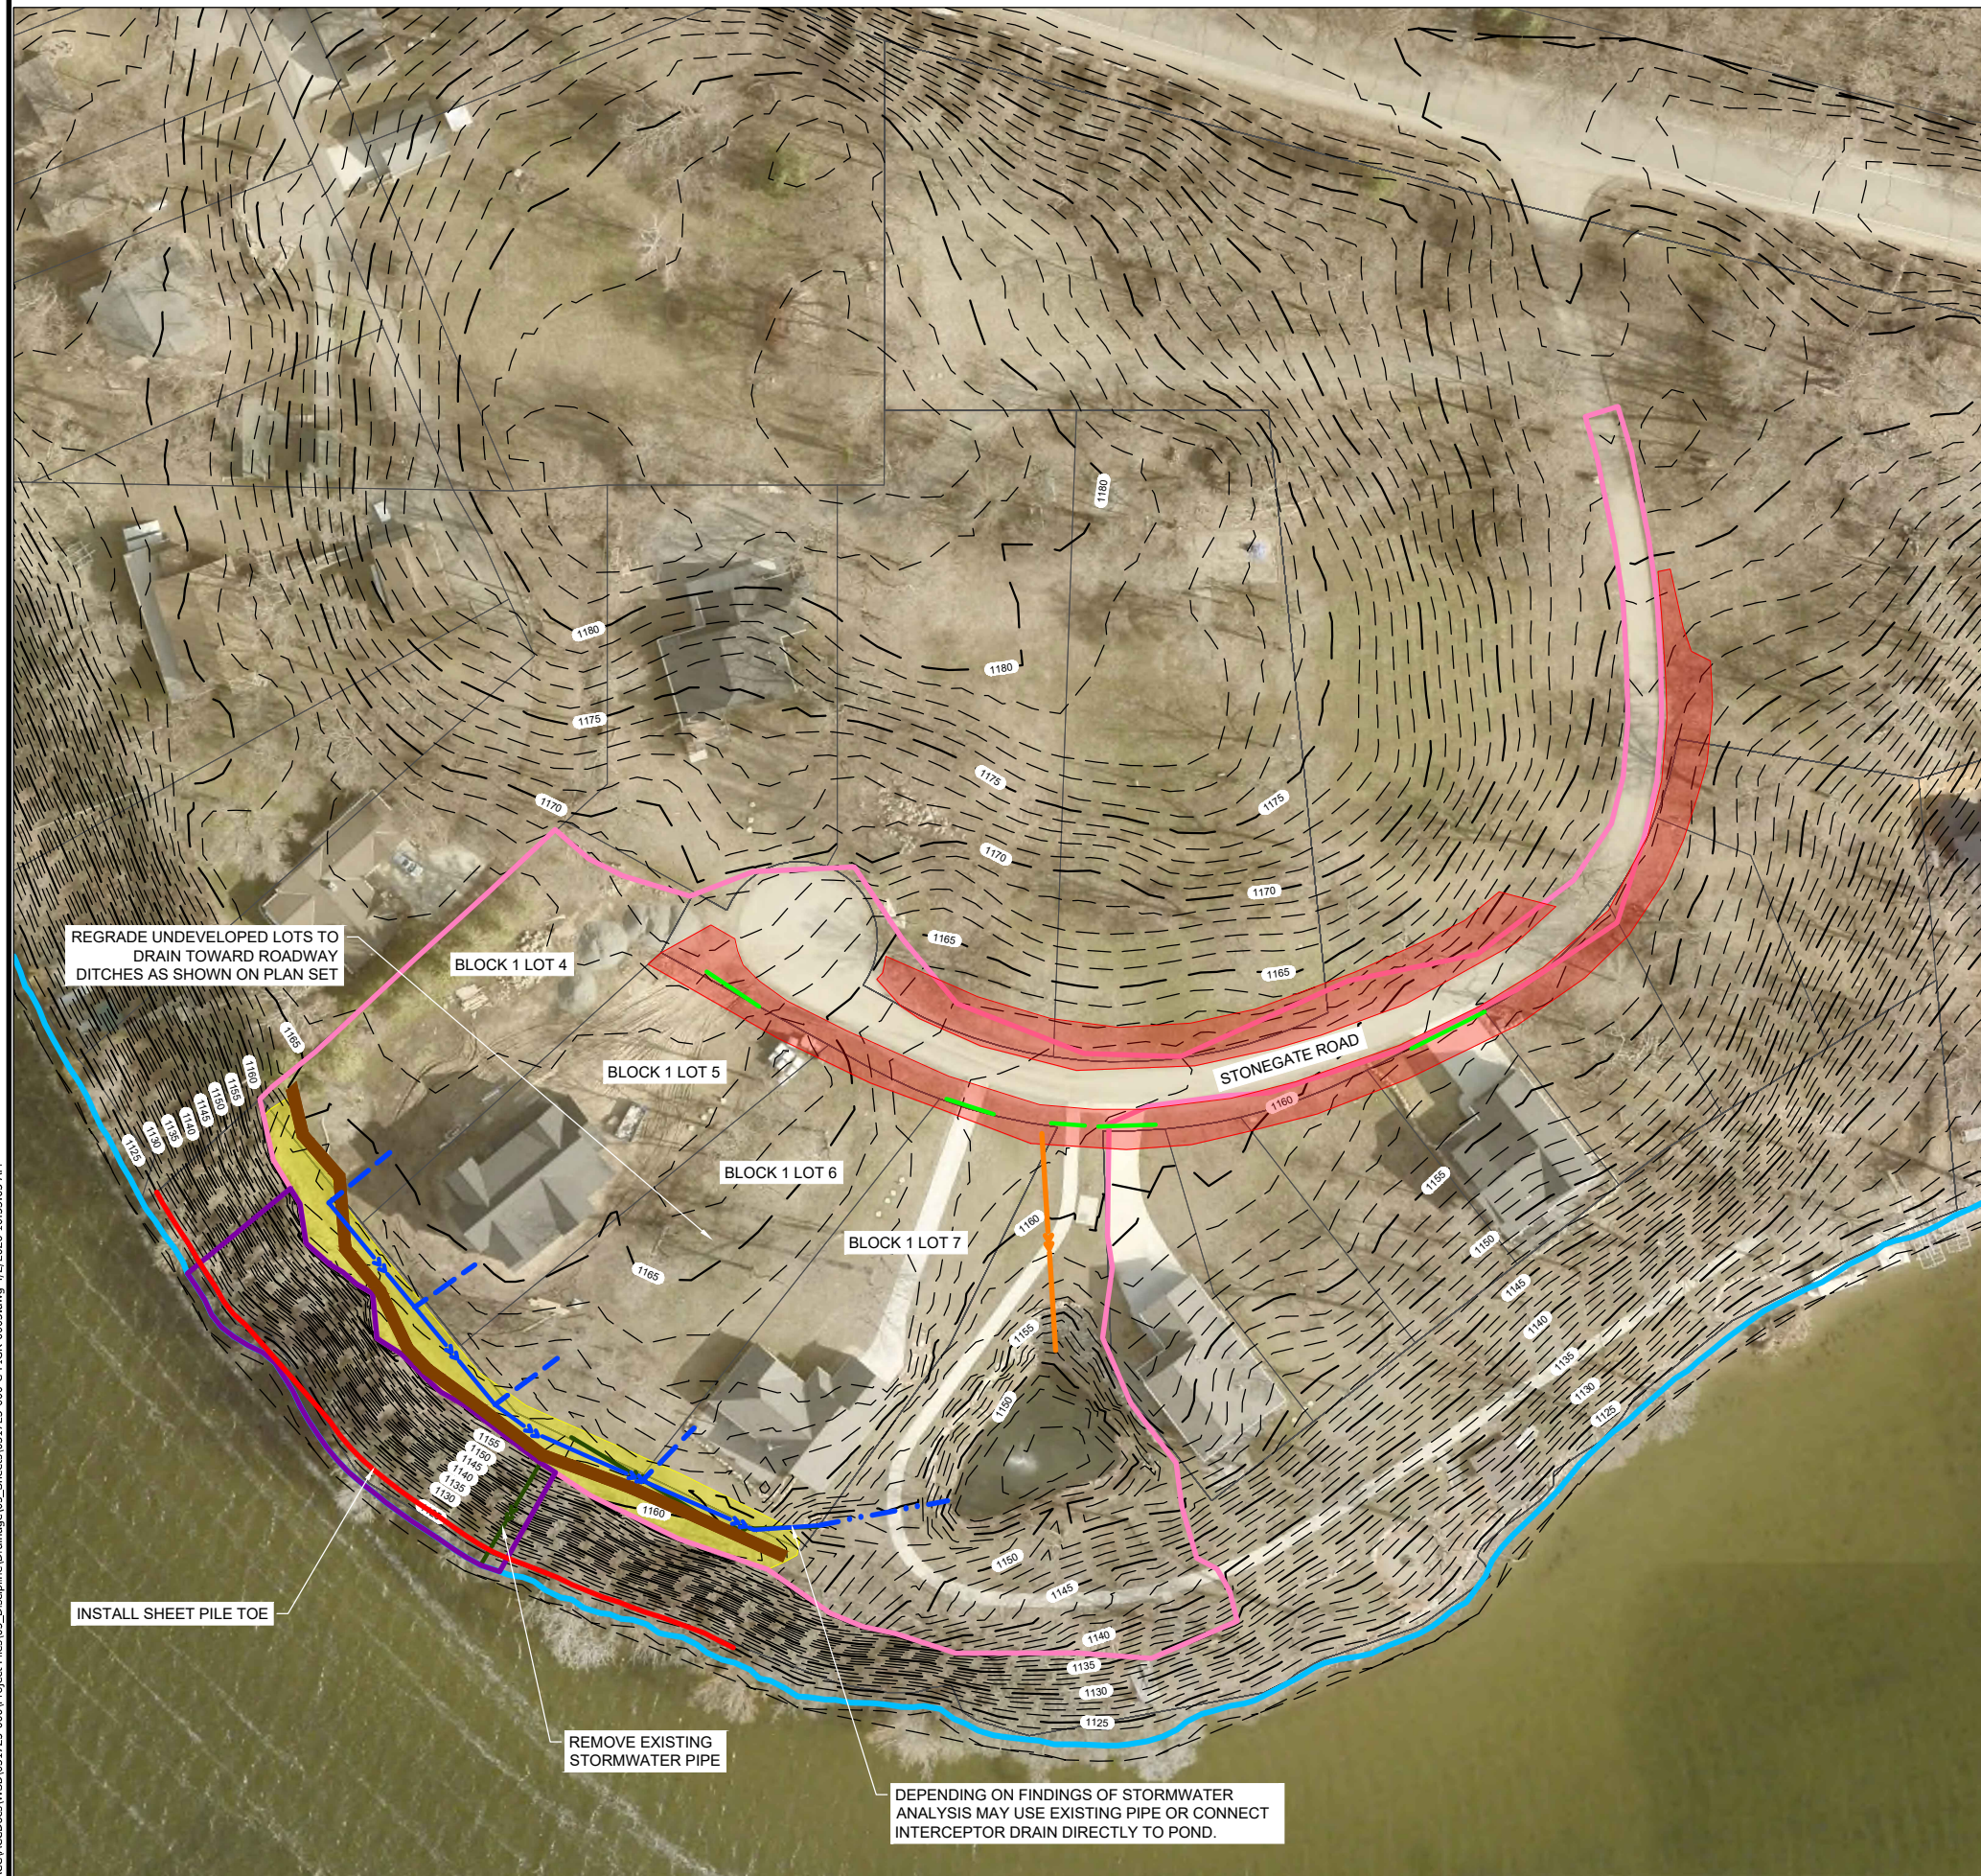
- PROPERTY LINE
- - - 1015 - - - EXISTING CONTOUR (MAJOR)
- - - EXISTING CONTOUR (MINOR)
- ▭ ERODING BLUFF AREA
- NORMAL WATER LEVEL
- >> EXISTING DRAINAGE PIPE
- ▭ SURVEY EXTENTS
- >> INTERCEPTOR DRAIN
- - - ROOF DRAIN
- · - · - POTENTIAL INTERCEPTOR DRAIN
- POLLINATOR SOUTHWEST SEED MIX 38-541 @ 20 LBS/AC (0.143 AC)
- BERM REALIGNMENT (5' WIDTH)
- PLANNED ROADWAY DRAINAGE DITCH
- >> STORMWATER PIPE
- >> DRIVEWAY CULVERT
- SHEET PILE TOE (330 LF)

Sheet pile provides toe protection and would reduce the likelihood of bluff failure at the toe of the slope. Preliminary design assumes that the sheet pile would extend approximately 5 feet above the normal water surface elevation of the lake. Installing sheet pile would not stabilize the bluff face itself but it could be combined with vegetated stabilization or MSE to stabilize the bluff face. Cost estimates presented below do not include that combination and assume that sheet pile would be installed alone.

Installation of a sheet pile toe would require large equipment for installation, but it would not change the slope of the existing bluff face. Due to the steep bluff face the sheet pile would likely have to be installed from the water side. Installation of sheet piles would be expected to take 2-4 weeks during non-frozen ground conditions. Sizing of sheet piles, pile connections, depth that the piles would have to be installed, and detailed cost estimates would come from further design and be completed by a geotechnical engineer.

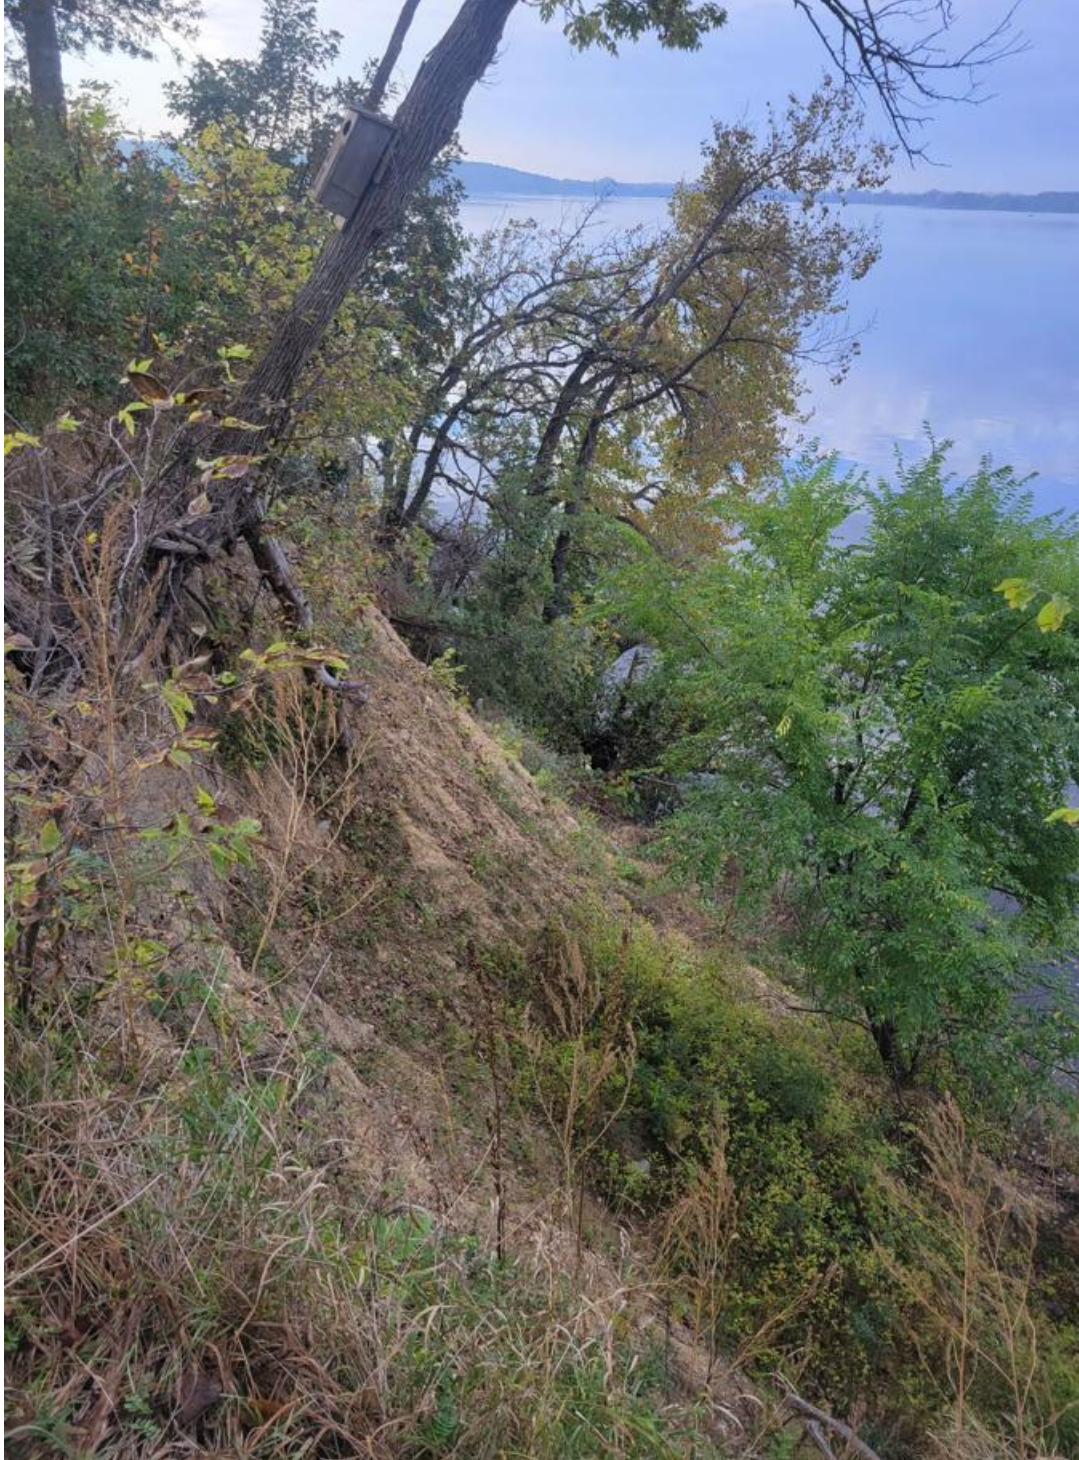
There are currently two houses above the eroding bluff, located on Lot 5 and Lot 7. The bluff within the subdivision is approximately 30 feet tall and 300 feet long. There are two actively eroding sections of the bluff. The first section is behind Lot 5 and is approximately 100 feet long. Residents say that a large section of this bluff sloughed away in June 2024. The second section is behind Lot 7 and is approximately 75 feet long. Residents say that the sloughing on this section occurred in August 2024. Conveyance of surface water runoff and subsurface infiltration within adjacent lots potentially attributed to bluff sloughing (Figure 3). Surface water runoff directions per WSB's topographic survey are included in Figure 1 and 3 of the report. In 2024, existing BMPs were constructed in cooperation with Stearns County SWCD which included a drainage swale and an existing berm at the top of the bluff to prevent future surface water runoff from adjacent residential lots flowing over the bluff.

Bluff sloughing behind Lot 5 from top of bluff

In order to assist with increasing vegetative cover on the bluff face and decreasing erosion, WSB recommends applying Proganics DUAL, a biotic erosion control matrix, along with native seed mixes suitable for site conditions. Proganics DUAL can be applied from the top of the bluff with a hydroseeder and includes both a topsoil builder and a bonded fiber matrix (BFM) for stabilizing the existing soils in place while the seed mixes take root and begin to grow.

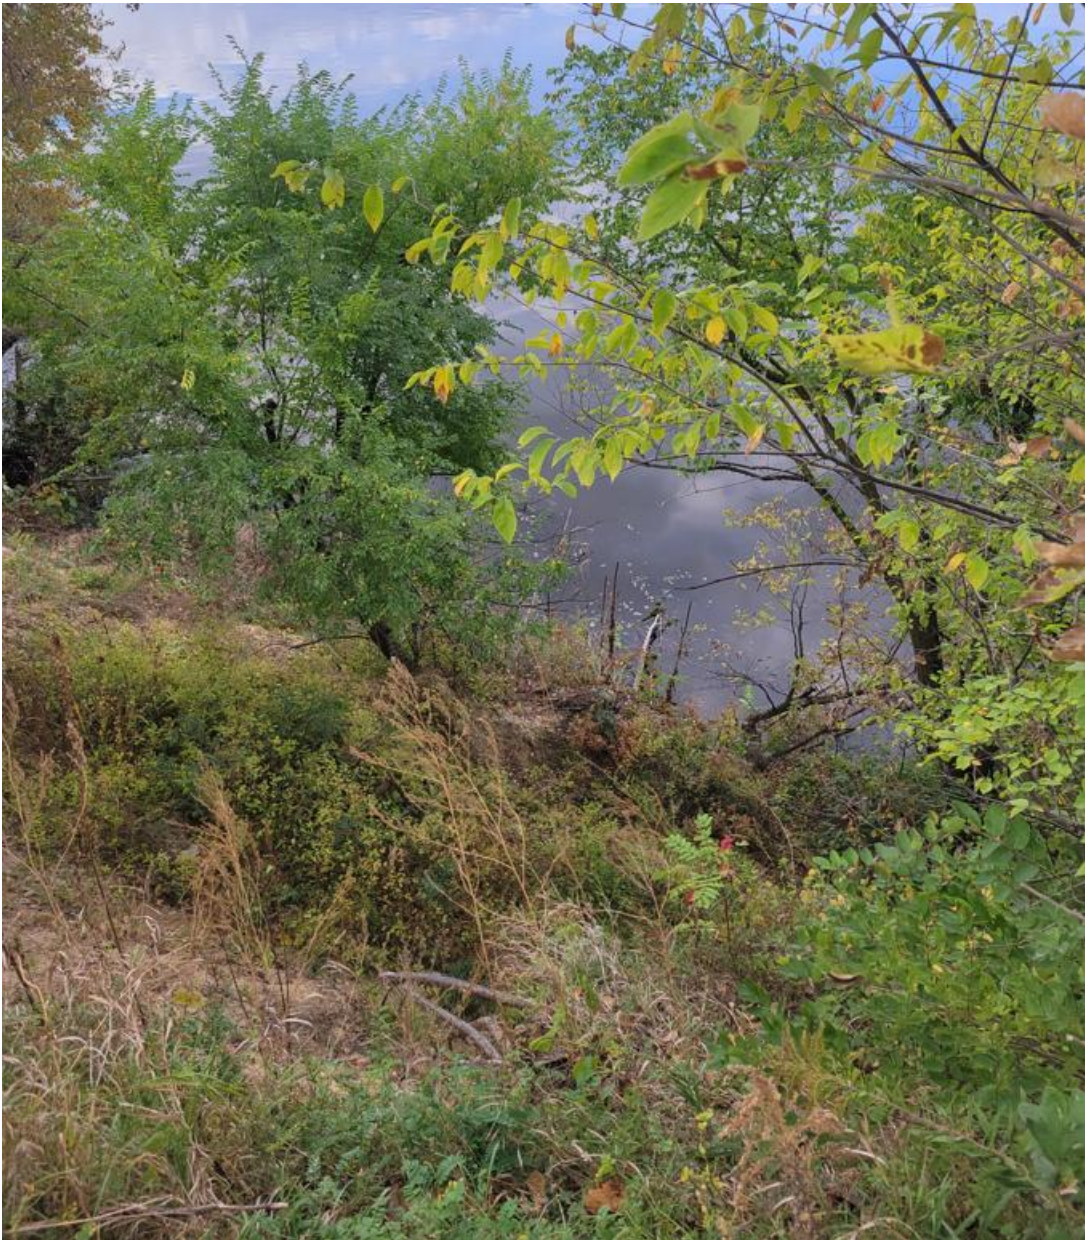
Bluff sloughing behind Lot 7 from top of bluff

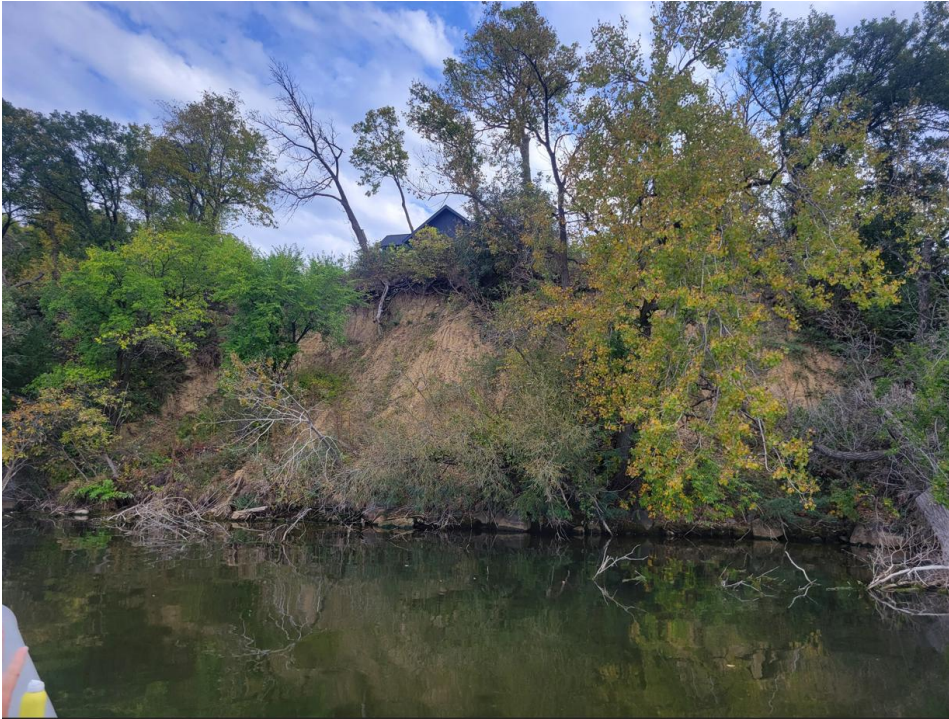
Bluff sloughing behind Lot 5 from Lake Koronis

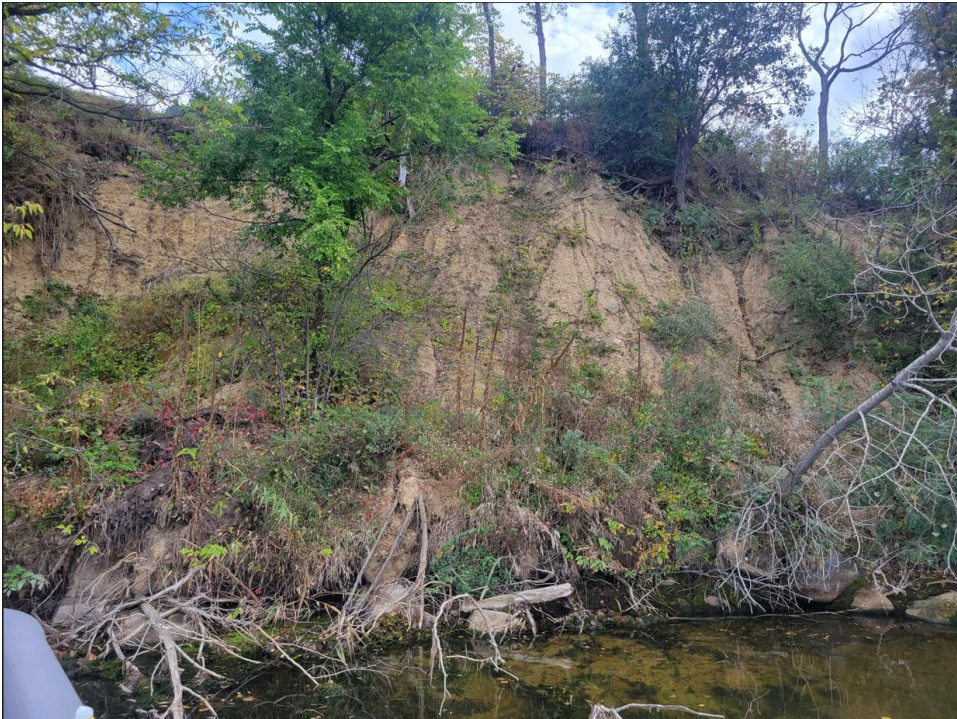
Bluff sloughing behind Lot 7 from Lake Koronis

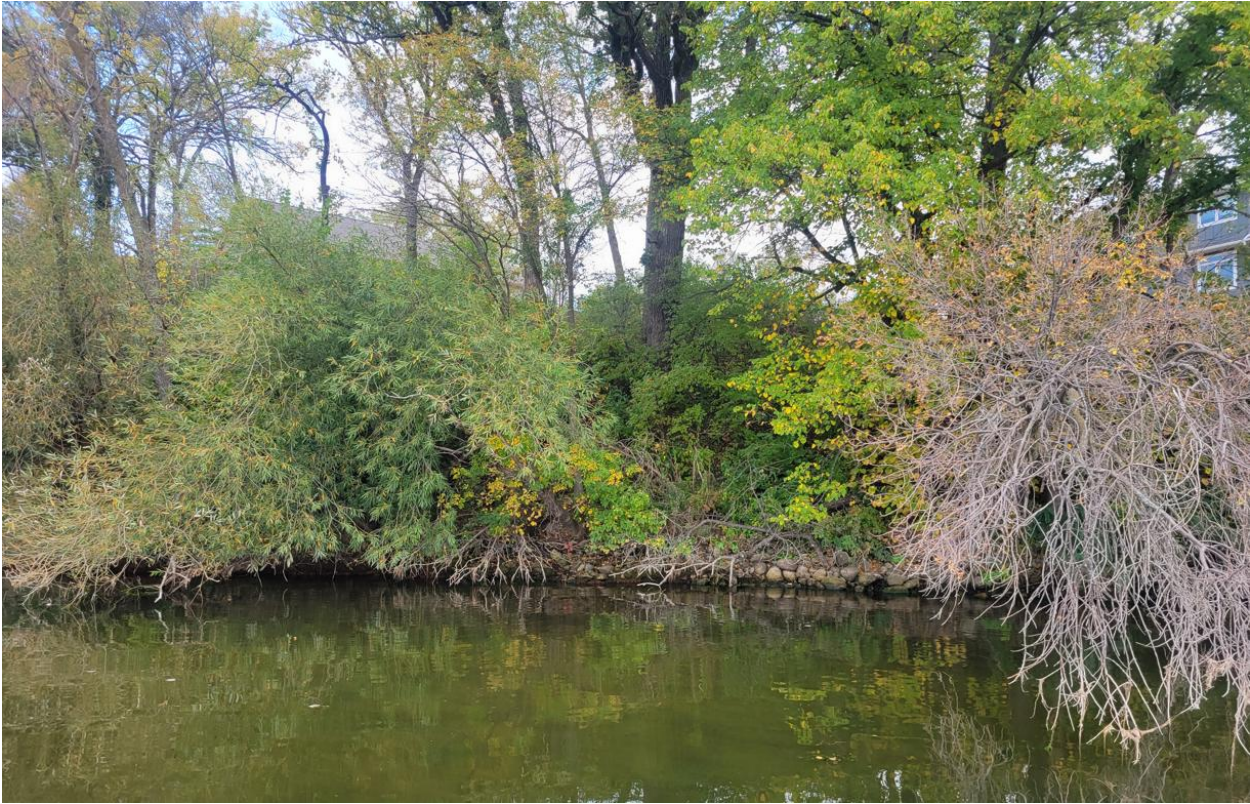
During the site visit WSB staff looked for evidence of seepage on the bluff face and did not observe any, indicating that groundwater is not likely to be the cause of the erosion issues. WSB also observed that the existing bluff toe is generally stable with both existing rock and mature vegetation. Finally, the sections of the existing bluff that did not experience sloughing are generally well vegetated with a mix of trees and perennial vegetation. This suggests that the soils, aspect, and grade of the slope are not incompatible with vegetative establishment. Homeowners also expressed a desire to preserve existing trees. Because of these reasons WSB does not recommend regrading the entire bluff to a more traditional slope angle; this would involve major

Typical stable bluff toe along Lake Koronis. Note mature vegetation and rock toe.

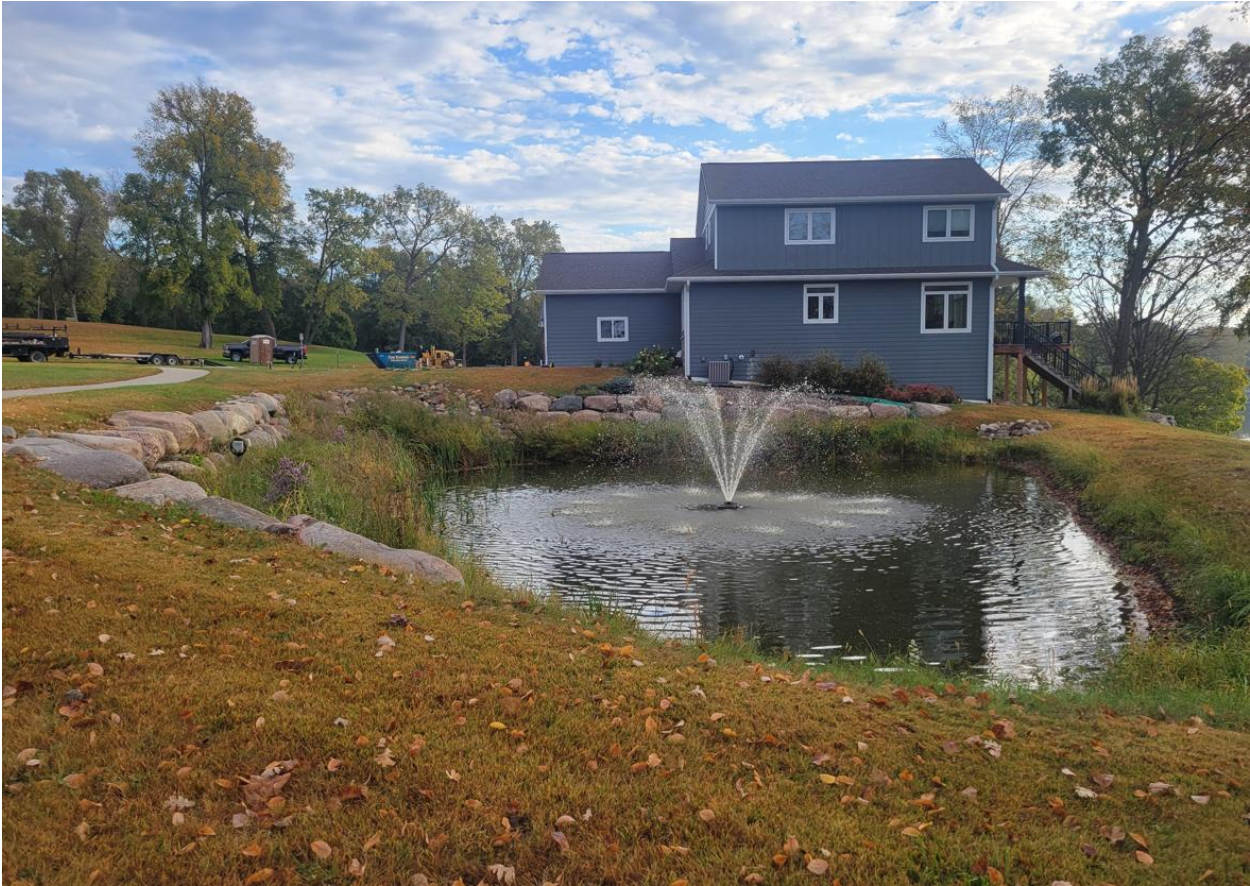
Existing stormwater pond

WSB recommends grading drainage ditches along both sides of Stonegate Road to match the developer's grading plan. This would route drainage from the development to the existing stormwater pond. Since houses have been constructed in the development, culverts would need to be installed under all driveways that lie within the drainage ditches. A stormwater pipe will be required to be installed to direct drainage from the ditches to the existing stormwater pond.

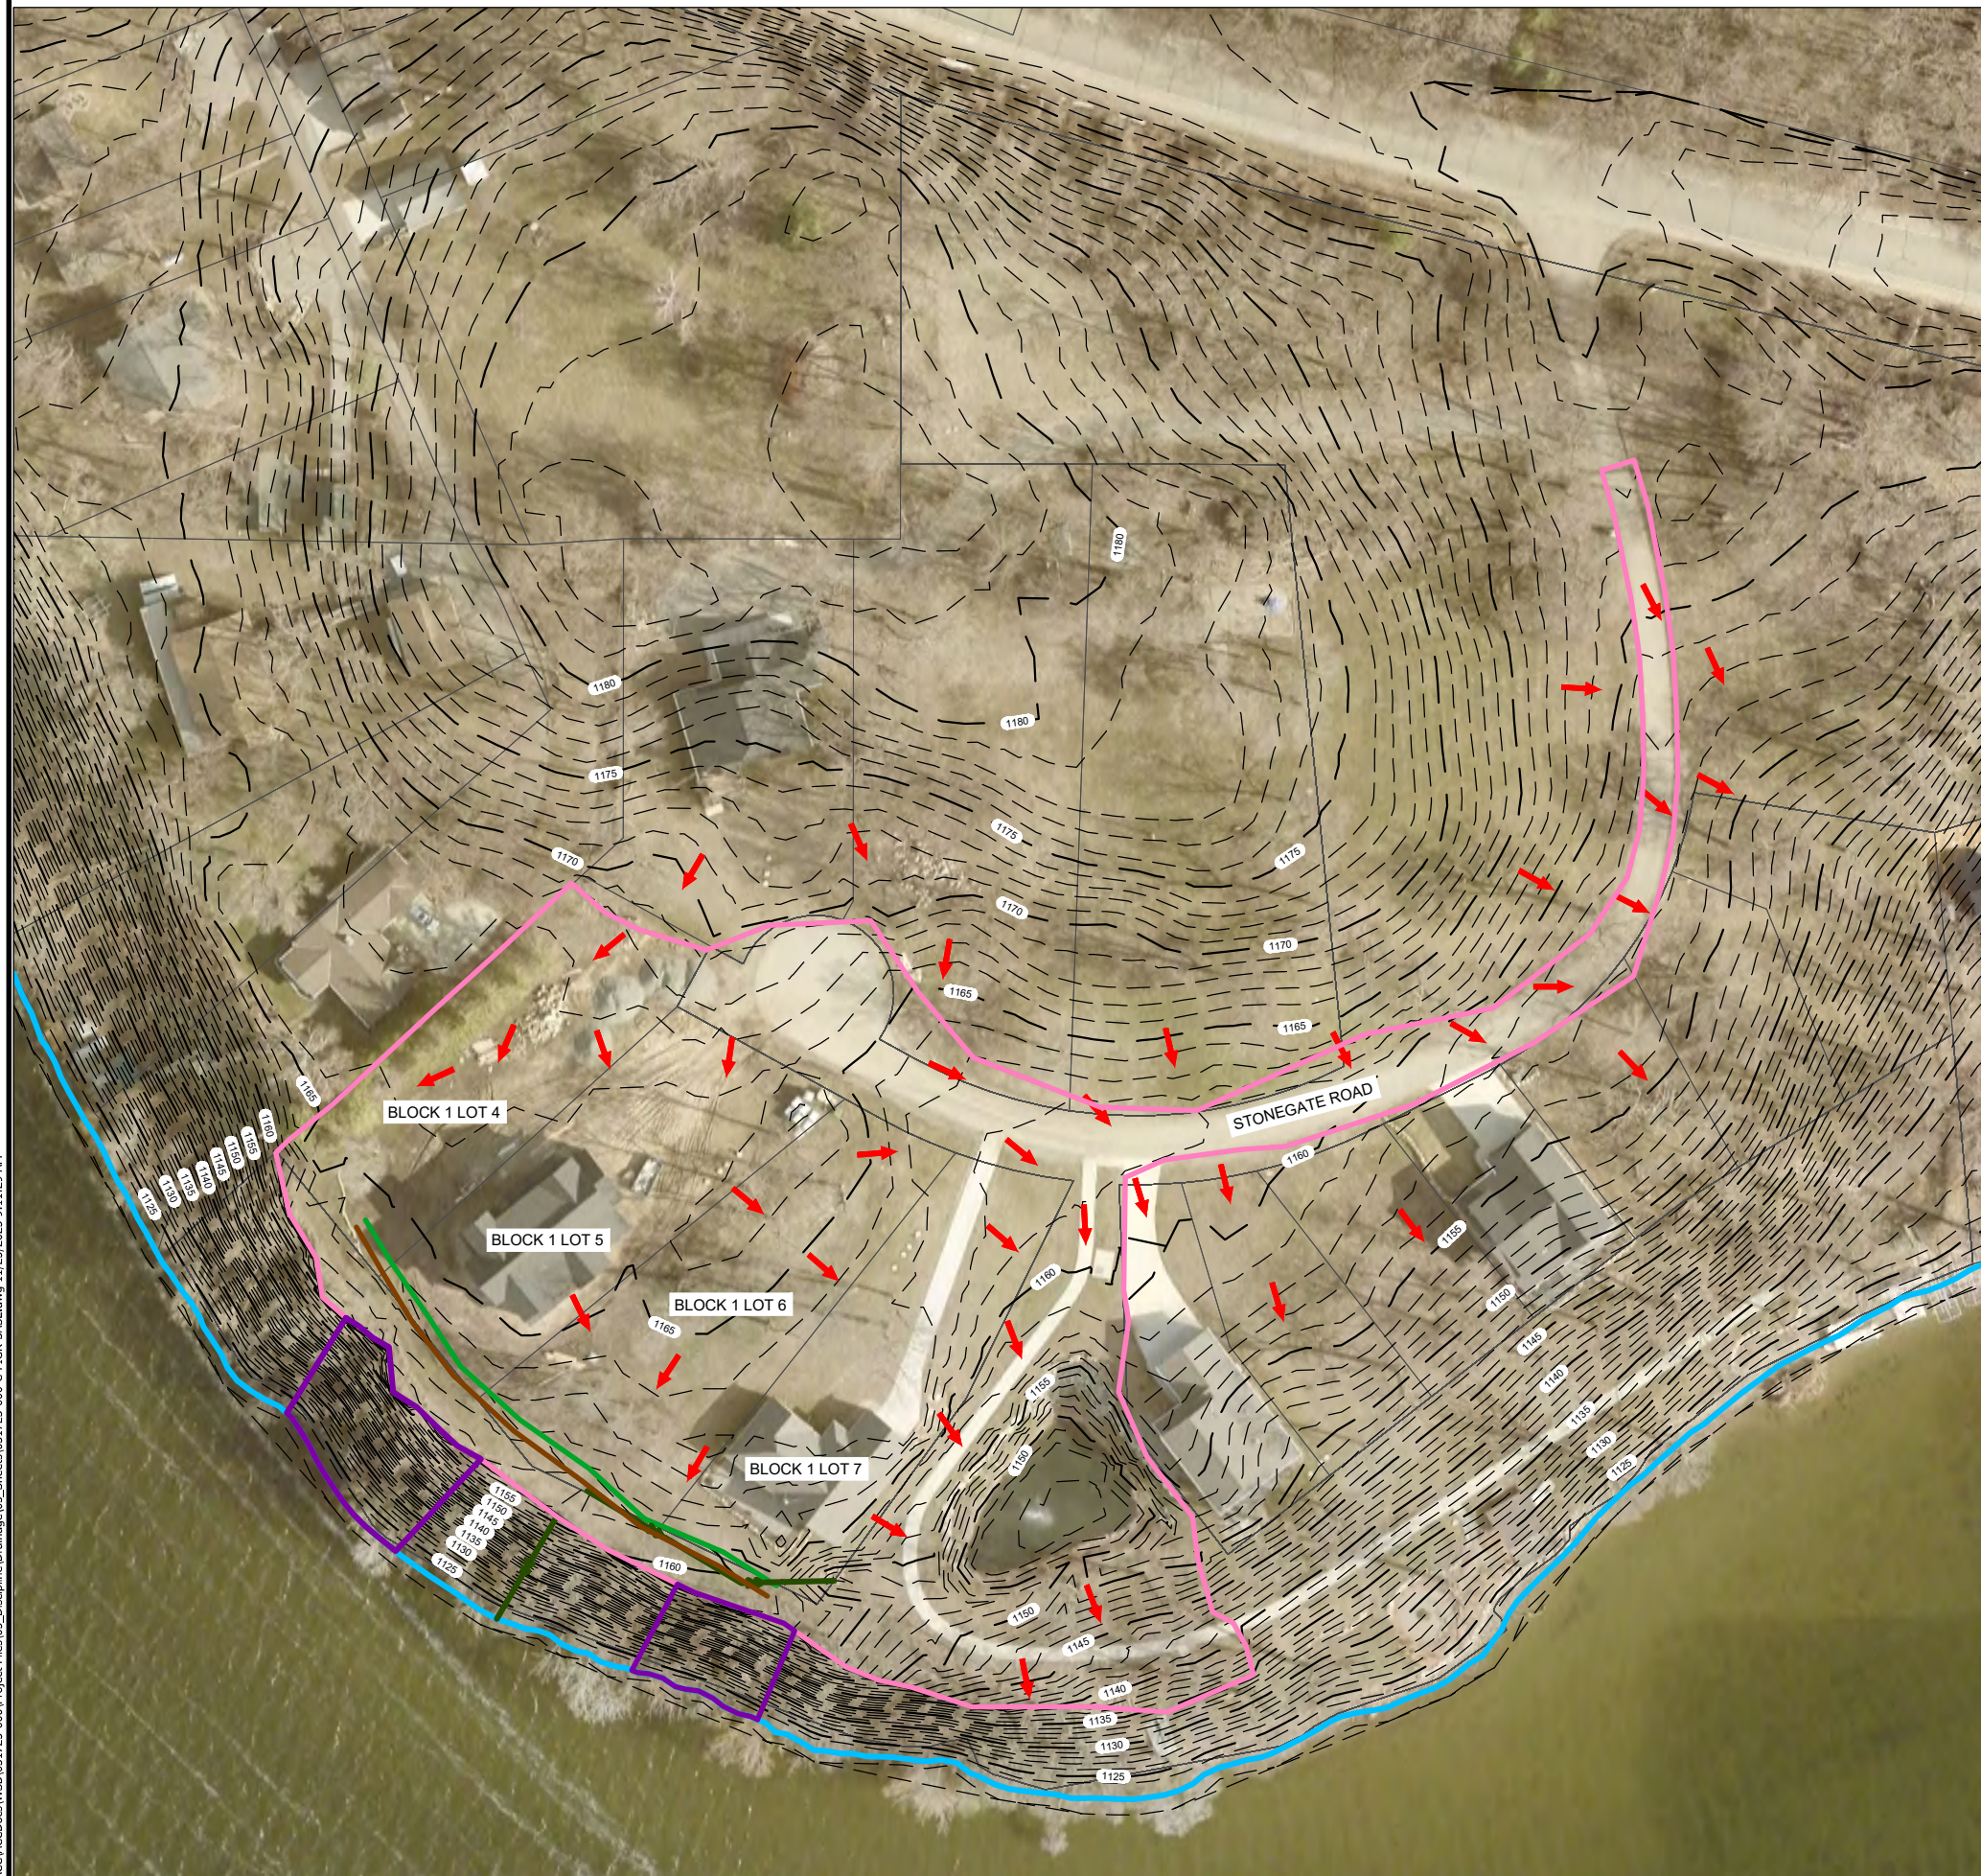
Existing stormwater management assessment includes review of existing topography and stormwater management vs what approved in the final grading plan and as-built plans. Figures 2 and 3 include the grading plans for the Stonegate on the Lake subdivision overlain with the results from WSB's 2025 topographic survey. Figures 4 and 5 show the revised grading plans for Stonegate on the Lake dated July 17, 2018, overlain with the existing topography survey. There are a number of significant differences between the planned and existing stormwater management which include the following.

- The drainage swale across the back of Block 1 Lots 4 – 7 was not constructed in the proposed location, nor was the revised earthen berm. Figure 3 shows the proposed location of the drainage swale. The later grading plan shown in Figure 5 shows that the swale has been converted to a berm, but both Figures 3 and 5 show that homes have been built within the berm or swale footprint. In 2024 the HOA constructed a small swale as well as an earthen berm to address surface runoff running over the bluff which is visible in Figure 2.
