To: Stonegate on the Lake HOA

Re: Lot Assessment Summary and Recommendations  
 WSB Project No. 031723-000

### Project Background

### History of Bluff Impacts

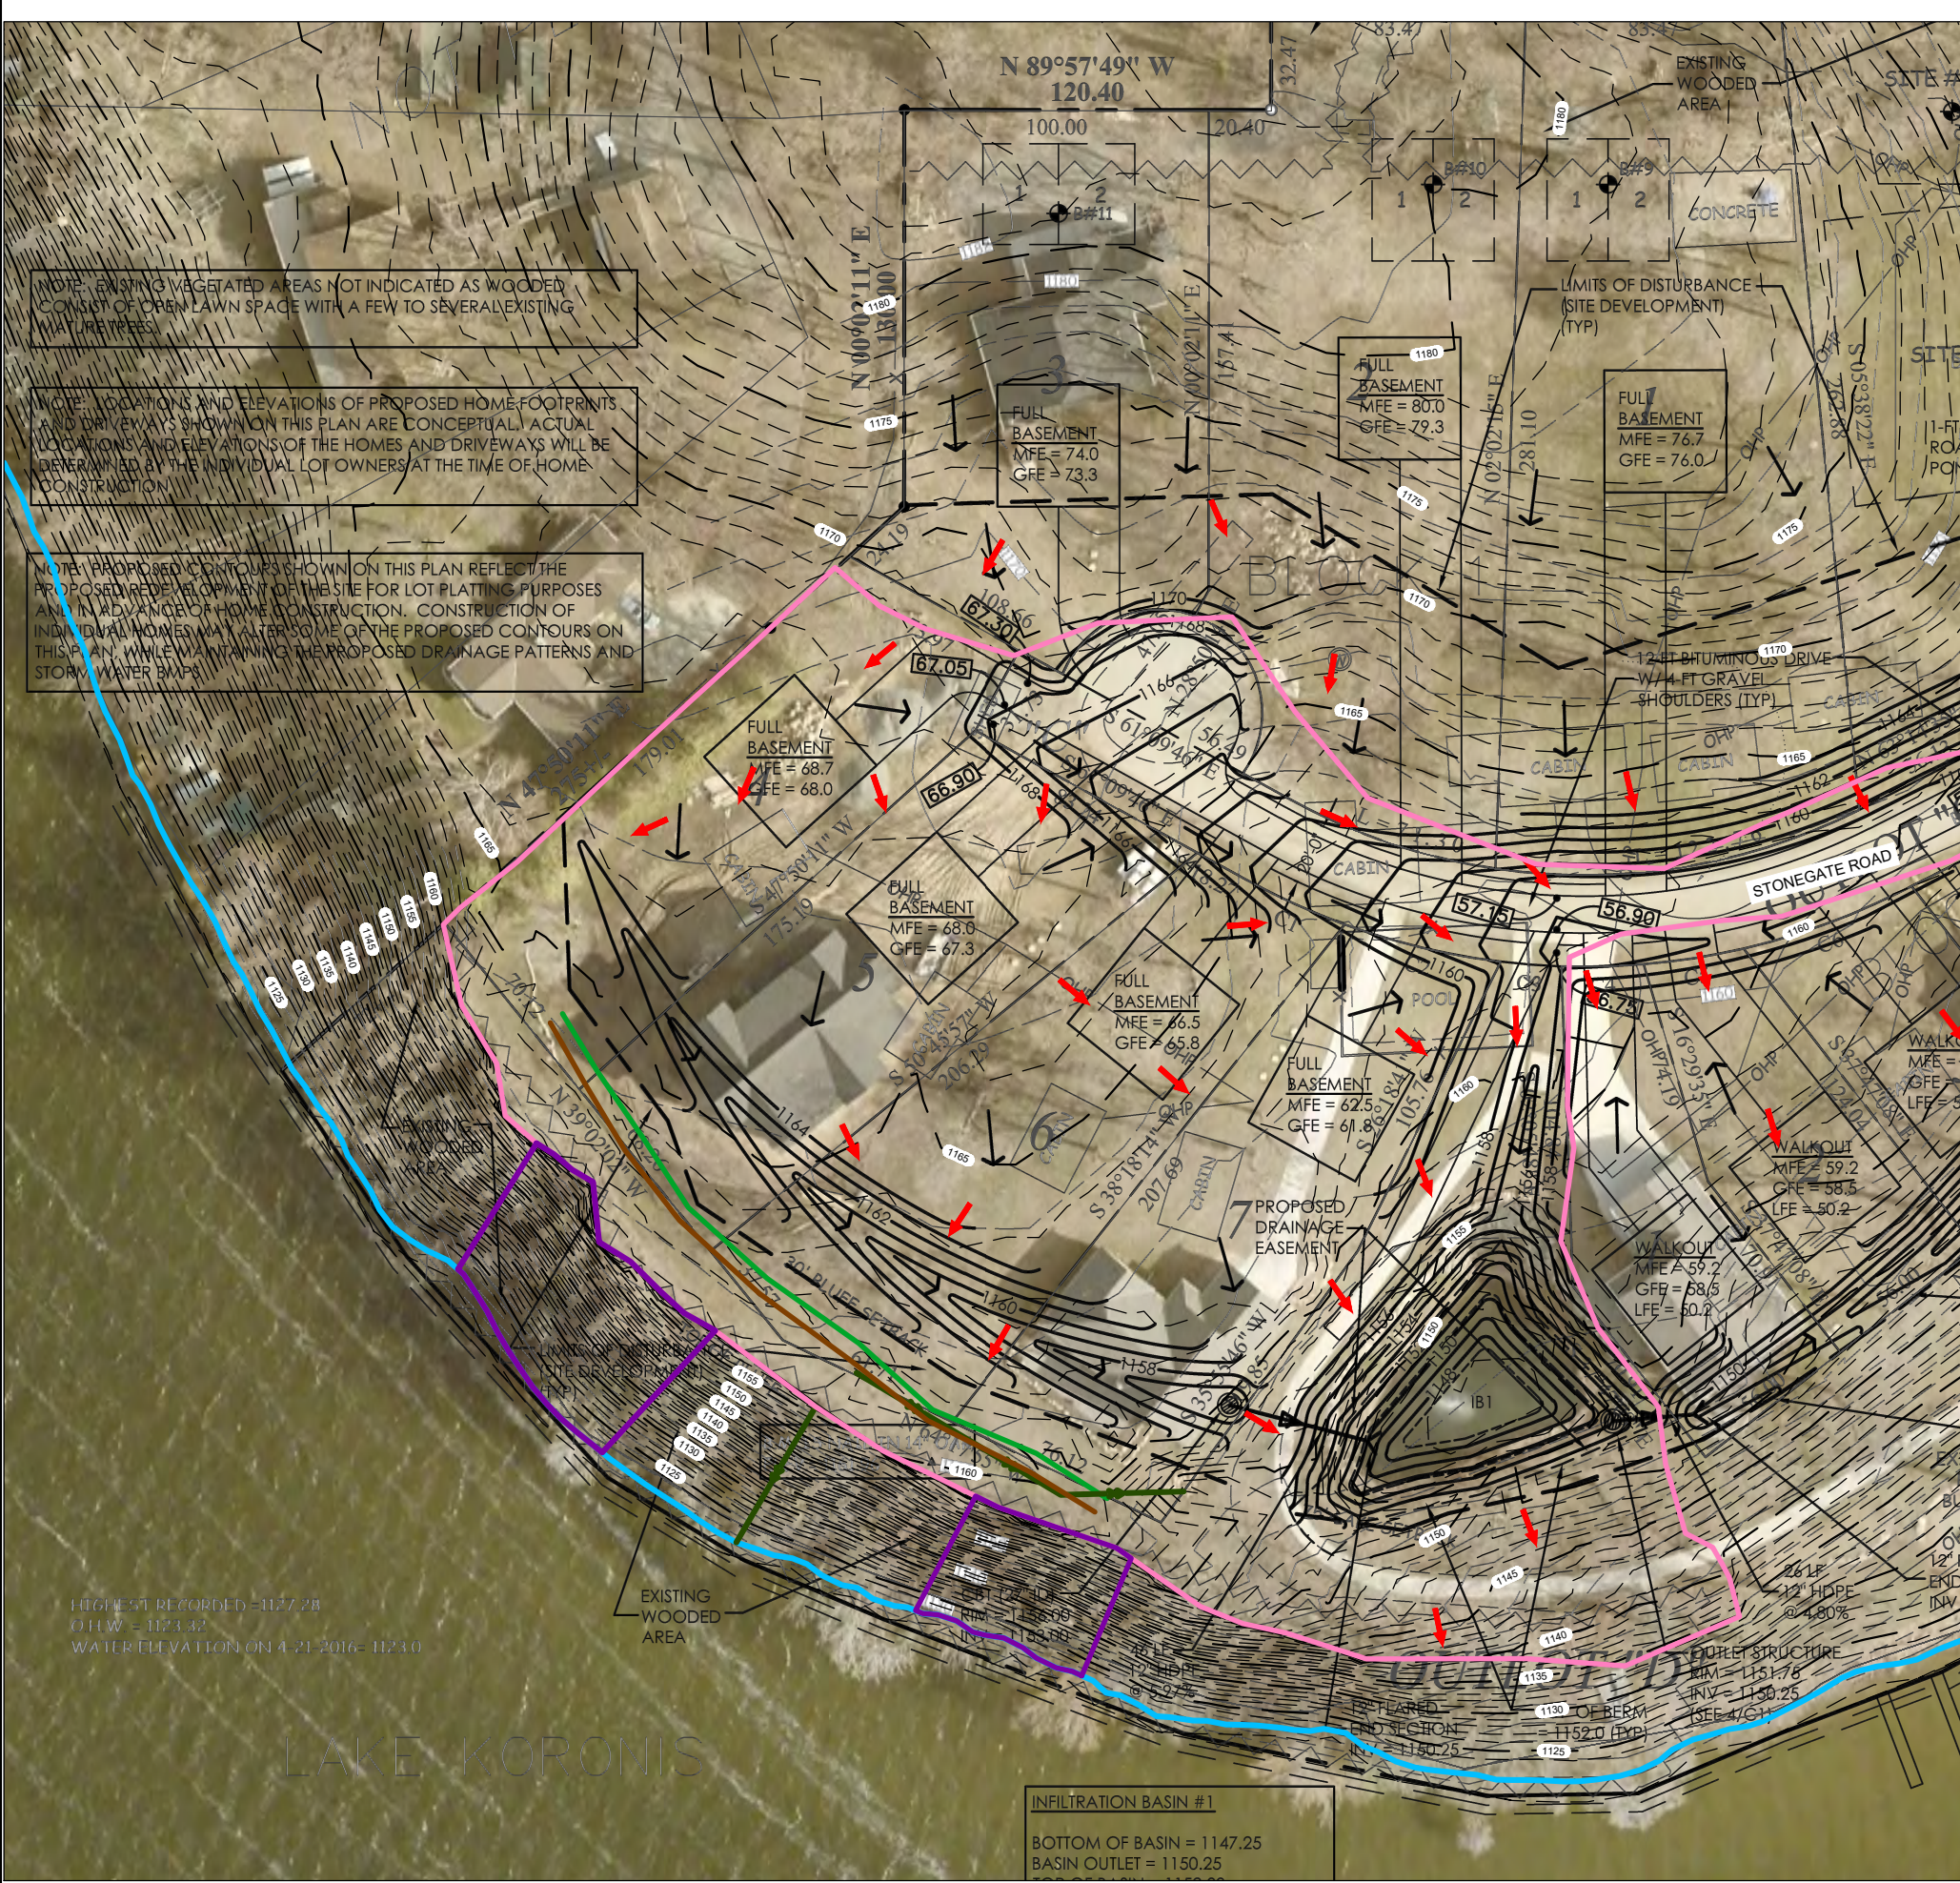
FIGURE 3

INFILTRATION BASIN #1  
 BOTTOM OF BASIN = 1147.25  
 BASIN OUTLET = 1150.25

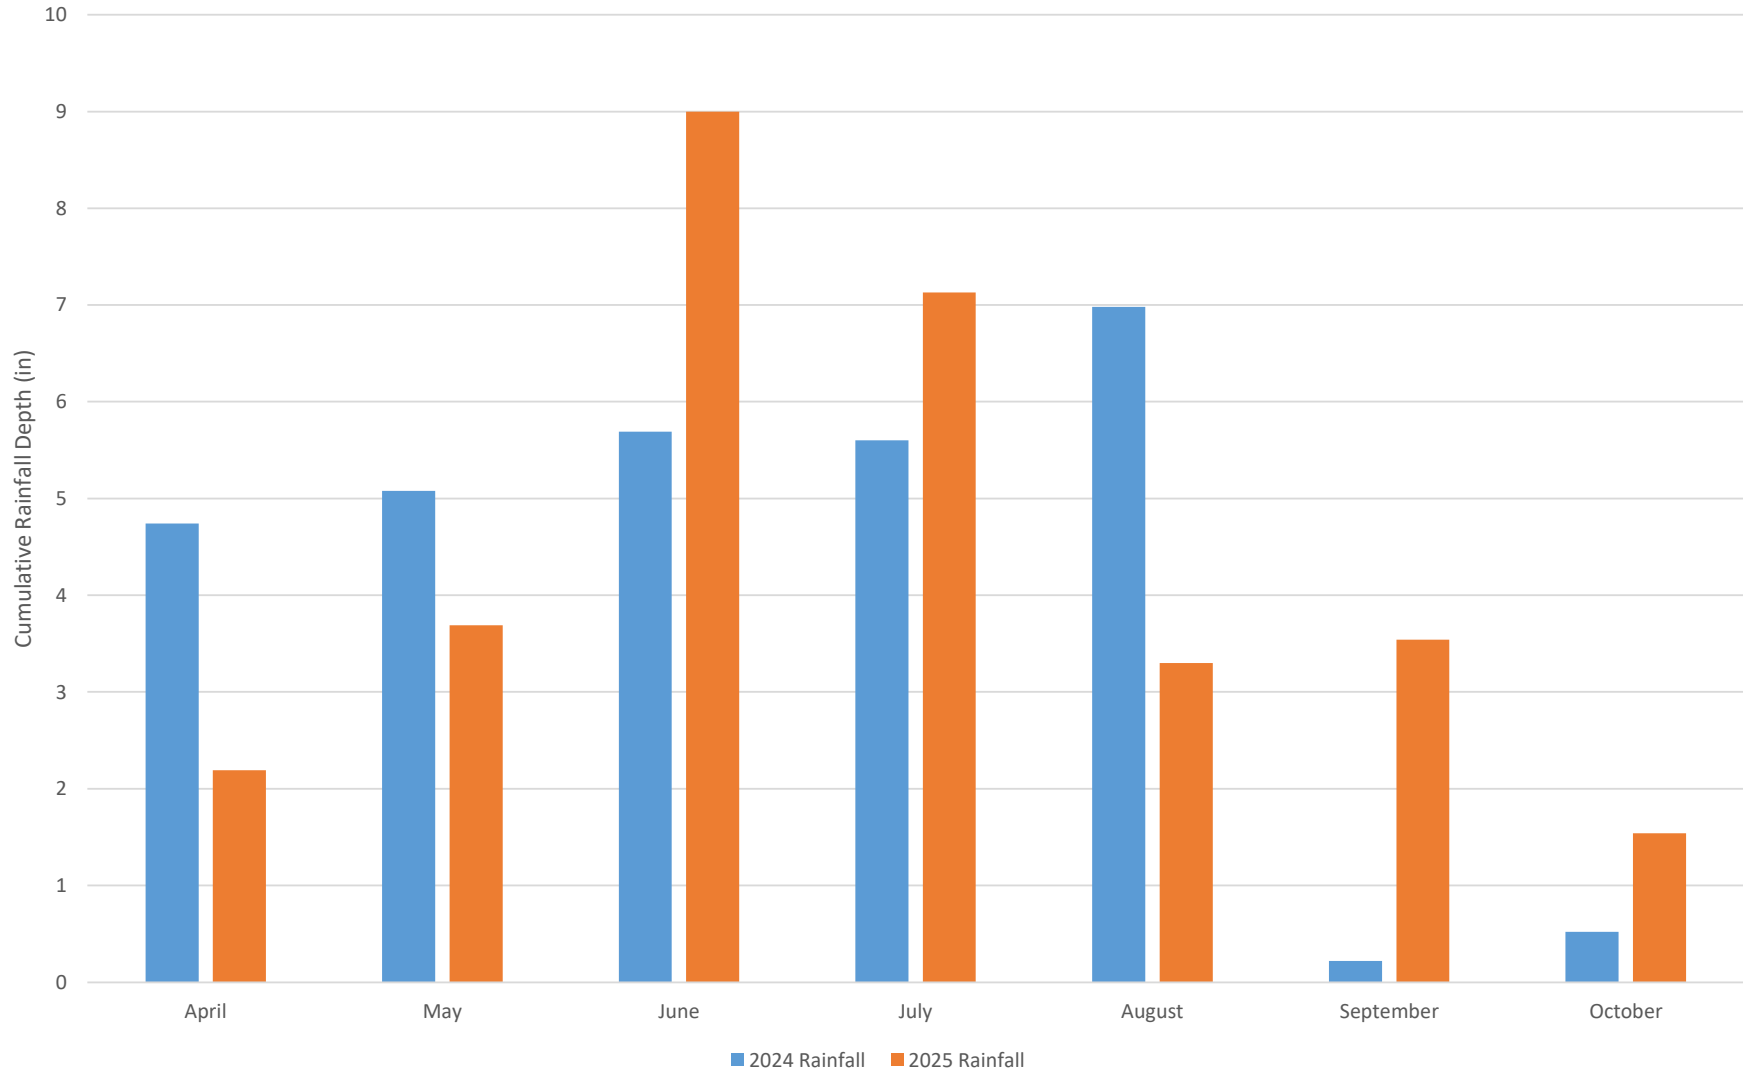
Figure 2 - 2024 and 2025 Total Precipitation by Month CoCoRAS Station #MN-SR-42

Table 1 - Monthly Precipitation Data (Station #MN-SR-42)		
Month	2024 Rainfall (in)	2025 Rainfall (in)
April	4.74	2.19
May	5.08	3.69
June	5.69	9.00

July	5.6	7.13
August	6.98	3.30
September	0.22	3.54
October	0.52	1.54
<b>Total Rainfall (in)</b>	<b>28.83</b>	<b>30.39</b>
